SERVICE BULLETIN

Model: Evora

Number:
2009/15

TITLE: Water ingress; areas of attention.

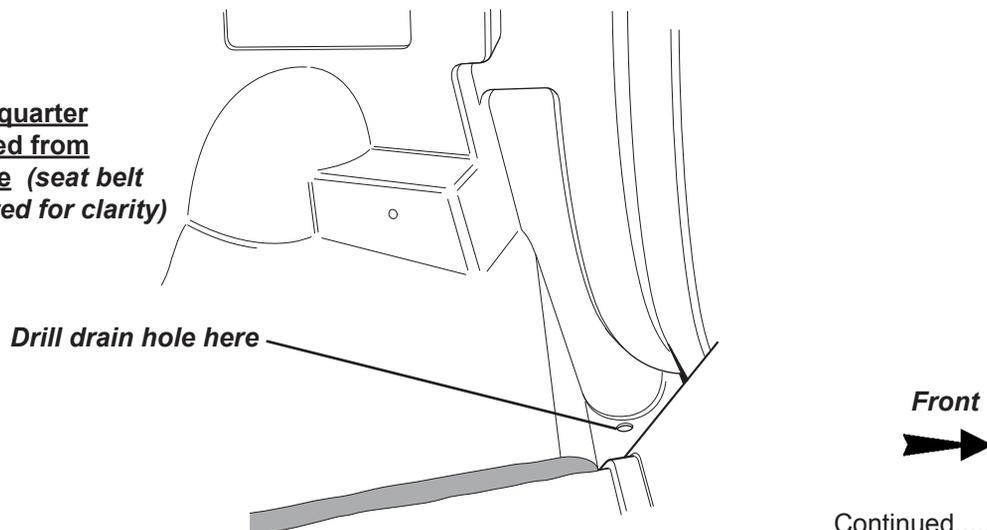
LHR quarter viewed from inside (seat belt omitted for clarity)

An incomplete bond path at the junction of the roof panel/body side/rear bulkhead can result in water accumulation in the body side wells beneath the ECU/rear fusebox panel (LH) and woofer speaker (RH). Remove the rear quarter trim panels (Service Notes section VE.12) and release the roof lining rear fixings.

Taking appropriate precautions to avoid contaminating the roof lining, backfill the joint area between roof panel/body side/rear bulkhead using Betaseal 1701 and a spatula. Also seal over the two rear clamshell fixings at each side; one just beneath the quarter window, and one along the waistline via the bodyside access hole.

Drain holes should also be provided for each body side well, behind the 'B' post, by using a flexible drill extension, or a long masonry bit to drill an 8 - 10mm diameter drain hole in the bottom of the deepest part of the well. Remove the seat belt reel if necessary for improved access. Seal the edges of the holes with touch-up (or black) paint.
