Date: 08.02.2012

Model: Evora - Prior '11MY VIN BH_12527

Number: 2012/03

Modification to the HVAC (Heating Ventilation & Air Condition) assembly drain tubes.

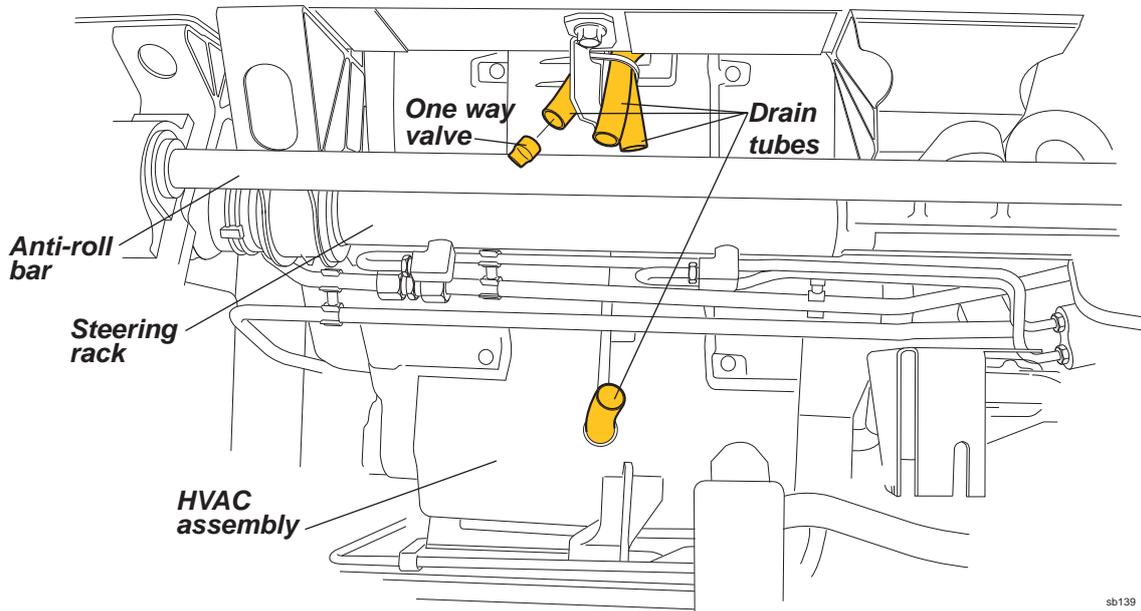
UNDERVIEW OF VEHICLE WITH HVAC UNIT IN SITU

The one-way valves located within the ends of the HVAC drain tubes were intended as an exit route for water ingress into the unit via the inlet duct or as a result of condensation collected below the air conditioning evaporator, whilst at the same time restricting airflow and dirt from entering the HVAC unit via this same tubing.

It is possible that the force required behind the valves to open them may be too great which could lead to the drain tubes becoming blocked, which, in extreme cases this can lead to:

- Reduction in the effectiveness of the HVAC systems demist function.
- Unpleasant odours emanating from the heater ducts.
- Water ingress into the passenger compartment from behind the footwell fuses via the recirculation intake vent.

1. Remove the front undertray.
2. Identify the two or four convoluted drain tubes (as fitted) from the HVAC unit, see illustration on page 1.
3. Holding one of the drain tubes, and using a pair of long nose pliers, grip the end of the rubber one-way valve protruding from its end and carefully pull out the valve and discard it.

4. Repeat this operation on the remaining drain tubes.
5. If the vehicle is prior to 2010 model year VIN. AH_41065 and TSB 2010/03 has **not** been carried out, then cut each drain tube so that it terminates around 10mm above the level of the undertray.

6. Clean out any dirt/debris that may have collected within the tubes or allow any water to drain out as necessary.
7. If not already done so, ensure the tubes (one or three as originally fitted) from the fan housing are routed in a downward direction ahead of the anti-roll bar, and tie wrap to either the steering rack mounting bracket or HVAC bracket (see illustration on page 1).
